Headlight lens reparation

Oslo RCAR 2010

Headlight cover repair

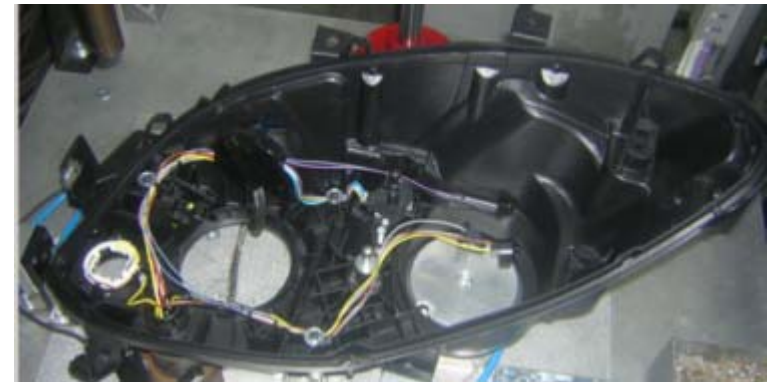
A) Body

Process: thermoplastic injection molding

Materials: talc-filled polypropylene (PP-TD40) or glass fibre-filled polypropylene (PP-GF30) are normally used.

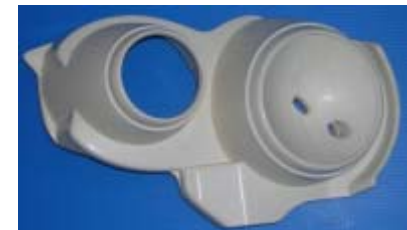
Riflettore sbavato

- Process:
 - Thermosetting injection molding
 - Molding
 - Robot + hand trimming
 - Basis painting: this is done to even out the surface of the molded piece
 - Washing (or brushing)
 - Painting (flow coating or spray)
 - UV Curing
 - PVD Metalization (sputtering metalization is also used): this is done in order to lay a thin layer of aluminium to enhance the reflection power of the item
 - Ionization: this is done in order to clean the item
 - Aluminizing: laying of aluminium in high vacuum **with process**
 - Protection: this is done in order to lay a layer of silicone monomer to prevent the corrosion of aluminium.
 - Materials. Base material: thermosetting material, unsaturated polyester resins BMC (Bulk Moulding Compound) with glass fibres and mineral charge.

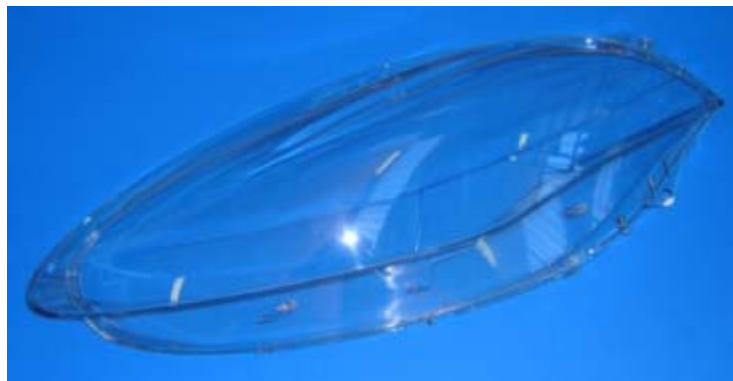
D) Lens

- Process:
 - Thermoplastic injection molding
 - Flow coating or UV curing (or thermic) spray painting (hardcoating). This is done in order to enhance the scratch resistance of the polycarbonat and to protect it from chemical agents and from UV rays.
- Materials. Base material: thermoplastic polycarbonat (PC)

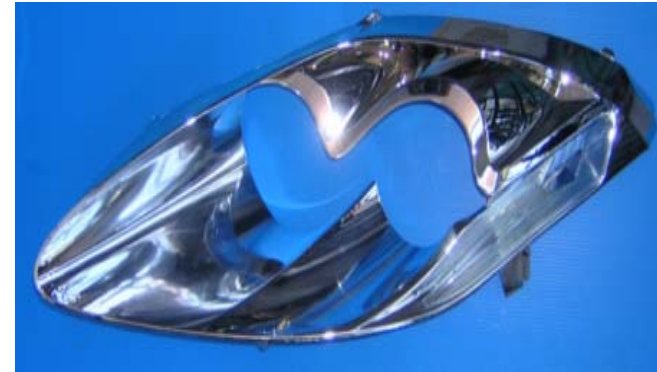
Cornice (Bezel)

- Process:
 - Thermoplastic injection molder
 - PVD metalization (sputtering metalization is also used): This is done in order to lay a thin layer of aluminium to enhance the reflection power of the item
 - Ionization: this is done in order to clean the item
 - Aluminizing: laying of aluminium in high vacuum **with process**
 - Protection: this is done in order to lay a layer of silicone monomer to prevent the corrosion of aluminium.
- Materials: thermoplastic polyamide (PA) or polybutylene terephthalate (PBT) or polycarbonat (PC)

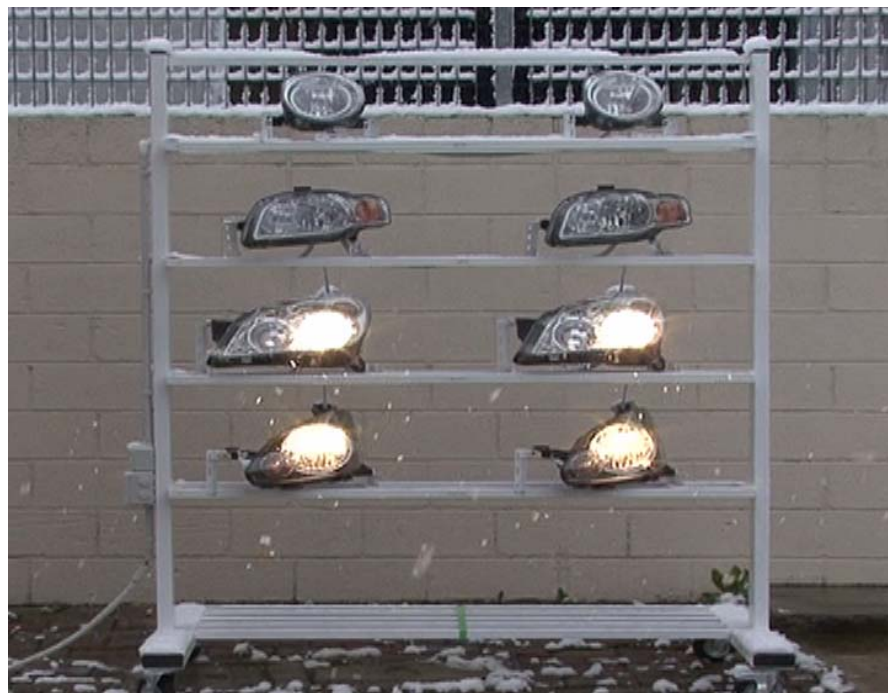
Operation tests

4 pairs of new headlights have been used. Each pair was composed of one painted headlight and one original headlight.

The headlights have been mounted on a special structure, which has been located outdoor. Each pair has been supplied with 13,5V voltage by means of a stabilized power supply for 1.278 hours. The lights have been cyclically turned out and on in order to simulate their use on a car in about 3,5 years of regular employment, according to studies done by ACI and by the Ministry of Infrastructures and Transports.

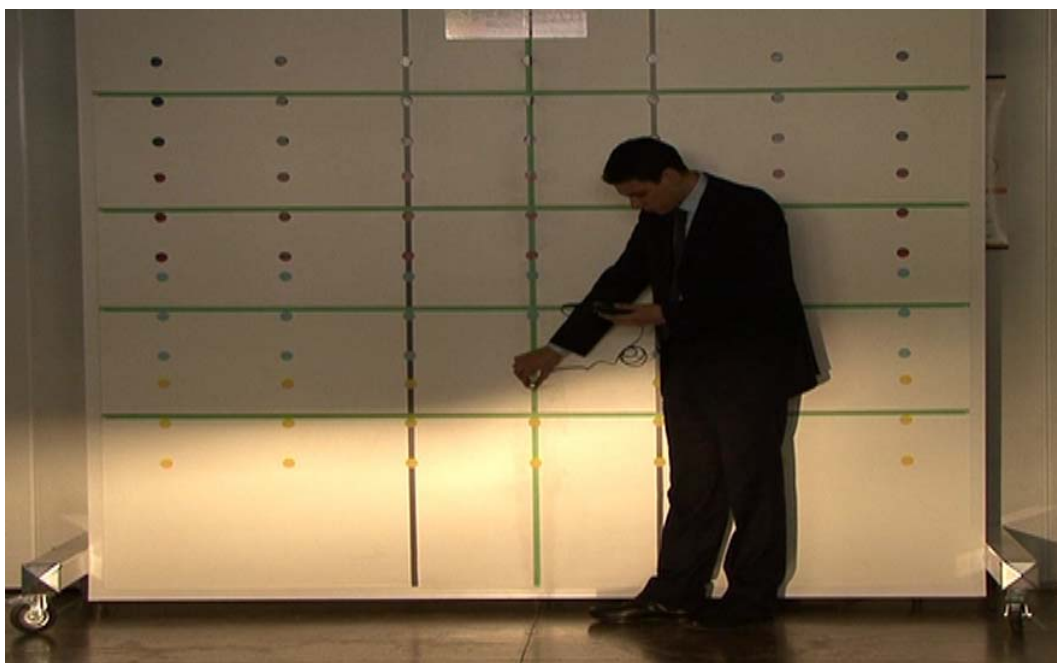
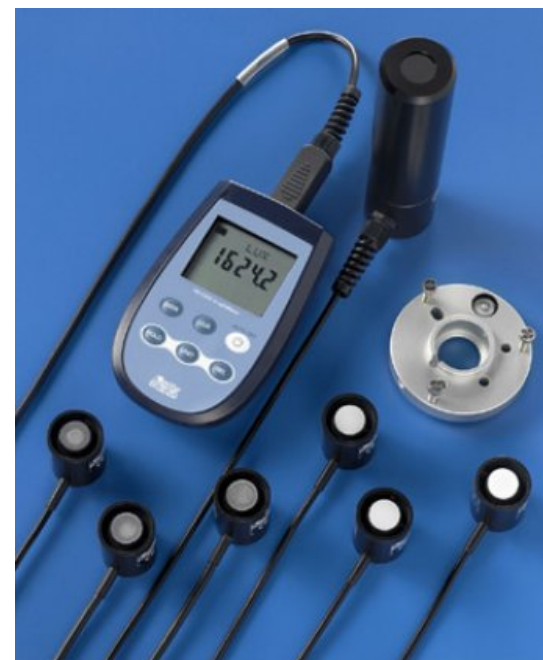
Results of operation tests

At the end of the test, we have measured the brightness of the light beam of each headlight, both with dirty and with clean surface, and this has been compared with the result obtained from the measurement made before the beginning of the test.

The variations of brightness for dirty is not significant (average difference 28lux)

No significant lighting loss has been verified after the tests, above all if we compare them with the variations of the surrounding light and with the effects of dirt. Furthermore, no structural alteration of polycarbonat have been found and the appearance is aesthetically excellent.

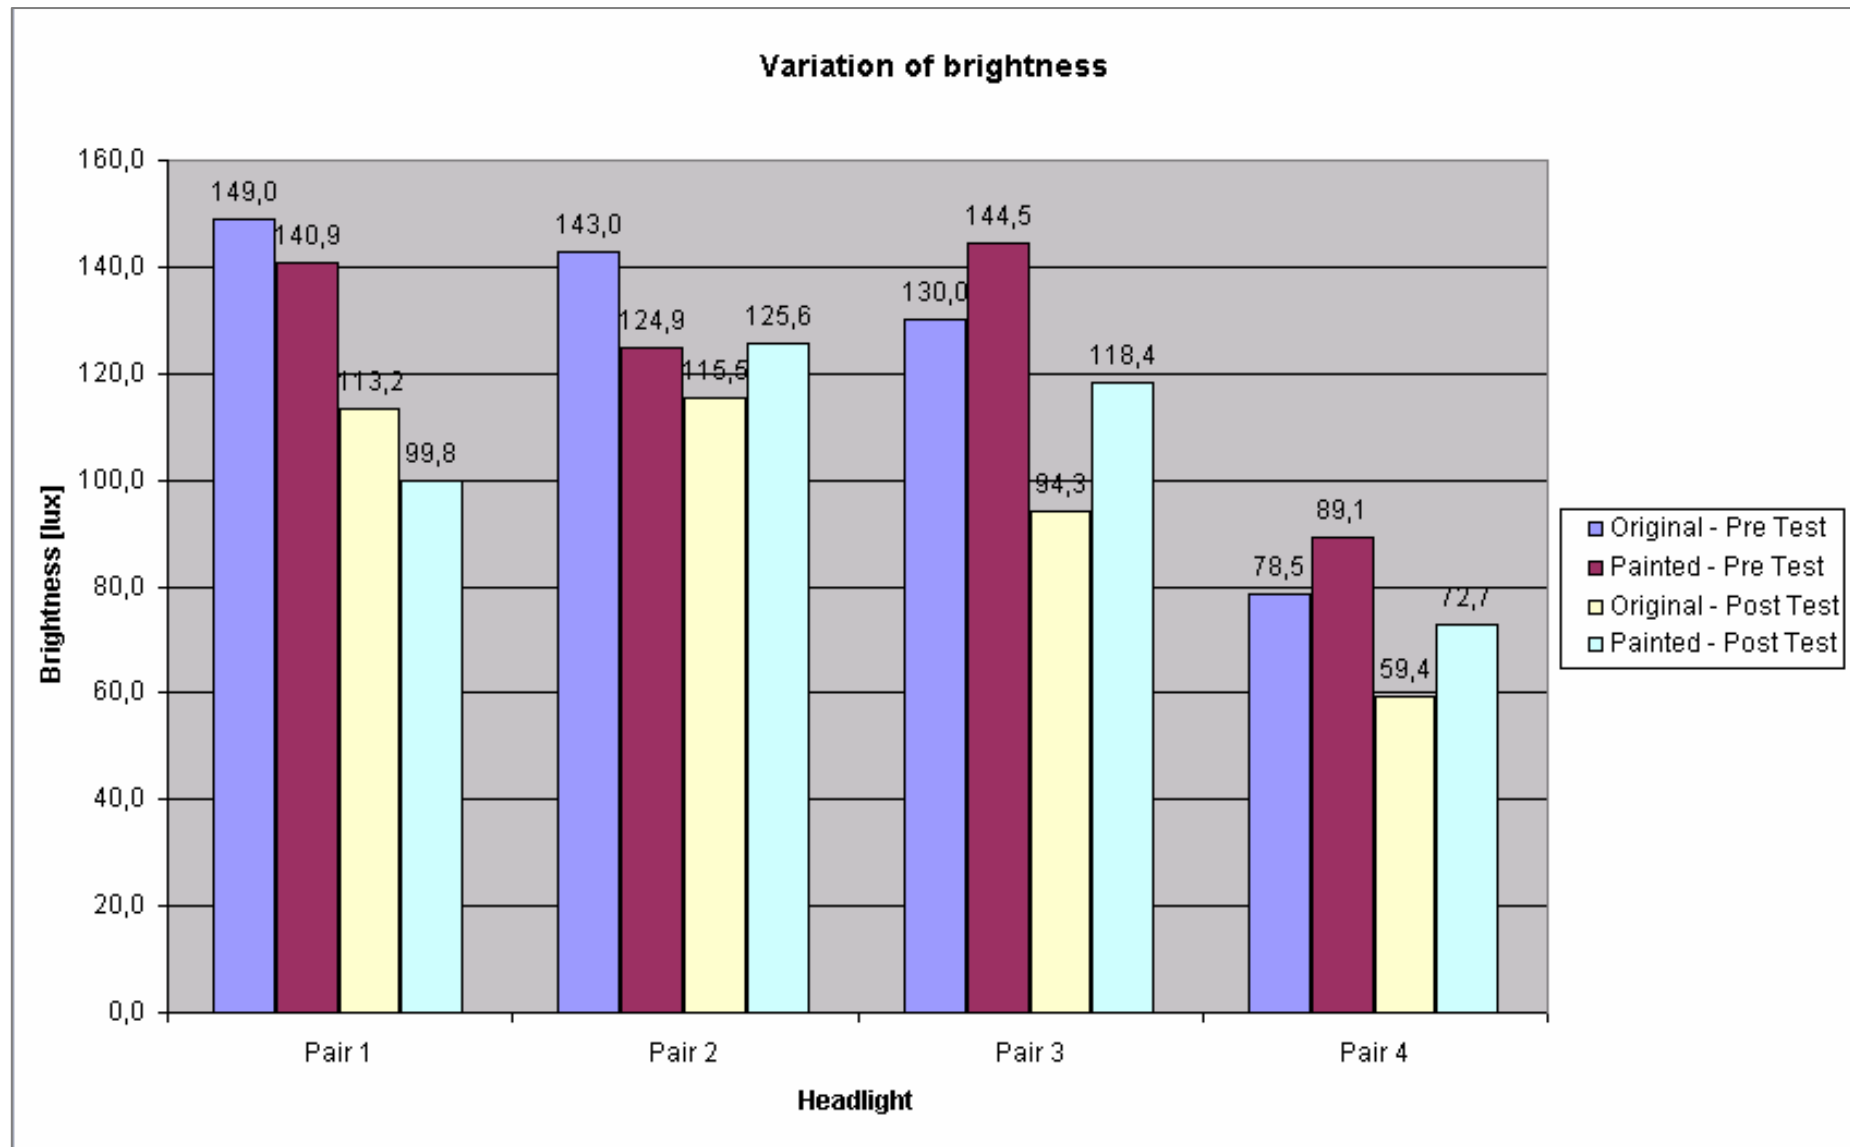
Variation of brightness following to painting

In order to verify the variations of brightness produced following to the laying of the superficial paint layer, the lighting produced by the new headlight has been compared with the lighting of the painted headlight, and the average lighting variation has been measured on 21 points for each headlight using a panel placed at a distance of 10 metres from the headlight.

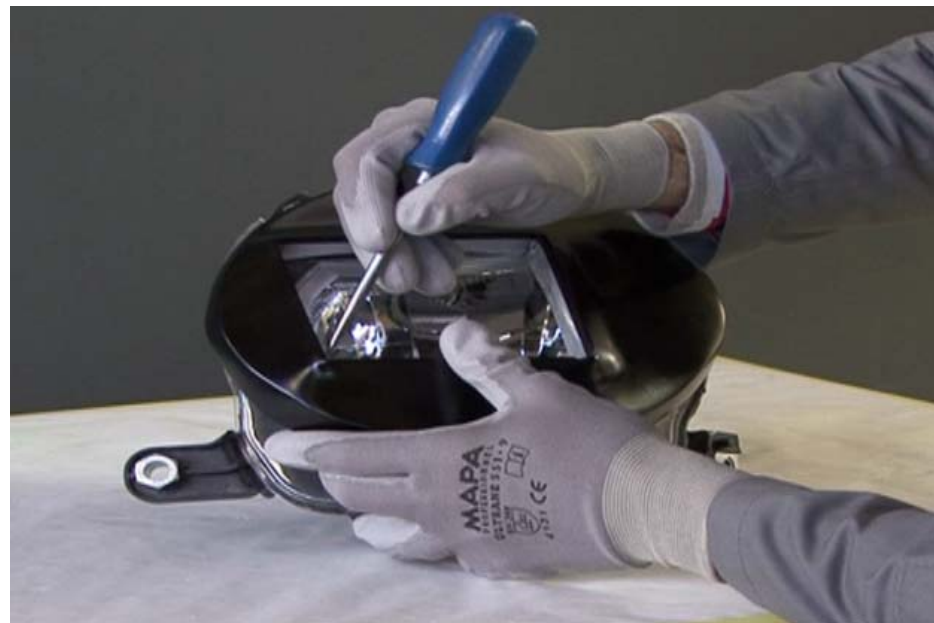
Preparation of the specimens

11 identical specimens have been cut from a matrix, and as many new headlights have been used.

The specimen have been numbered from 1 to 11: a two-component paint has been laid on the ones numbered from 1 to 5; a one-component paint has been laid on the ones numbered from 6 to 10; no paint has been laid on number 11 (master).

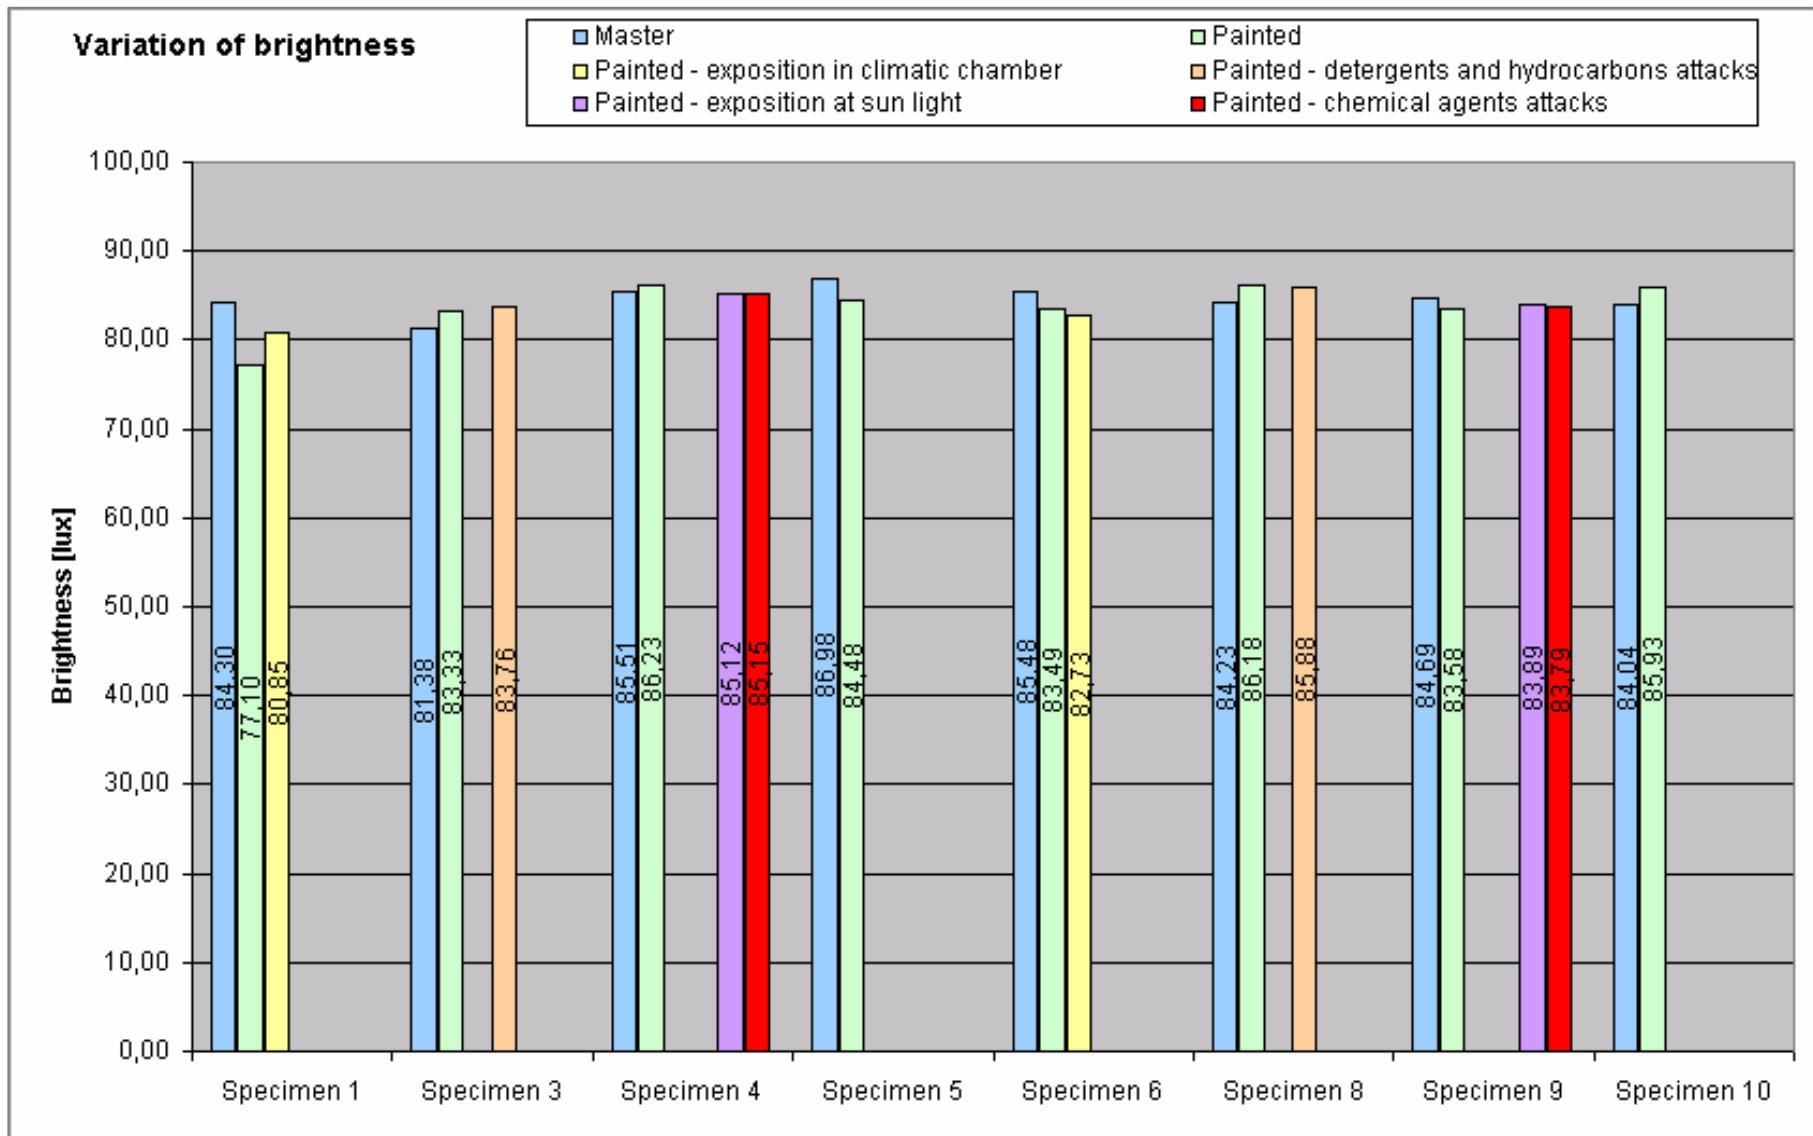
Aging tests

The specimens obtained have been tested in the laboratories of the University of Genoa, where they had to undergo the following tests:

- exposition in climatic chamber;
- exposition at sun light;
- chemical agents attacks;
- detergents and hydrocarbons attacks;

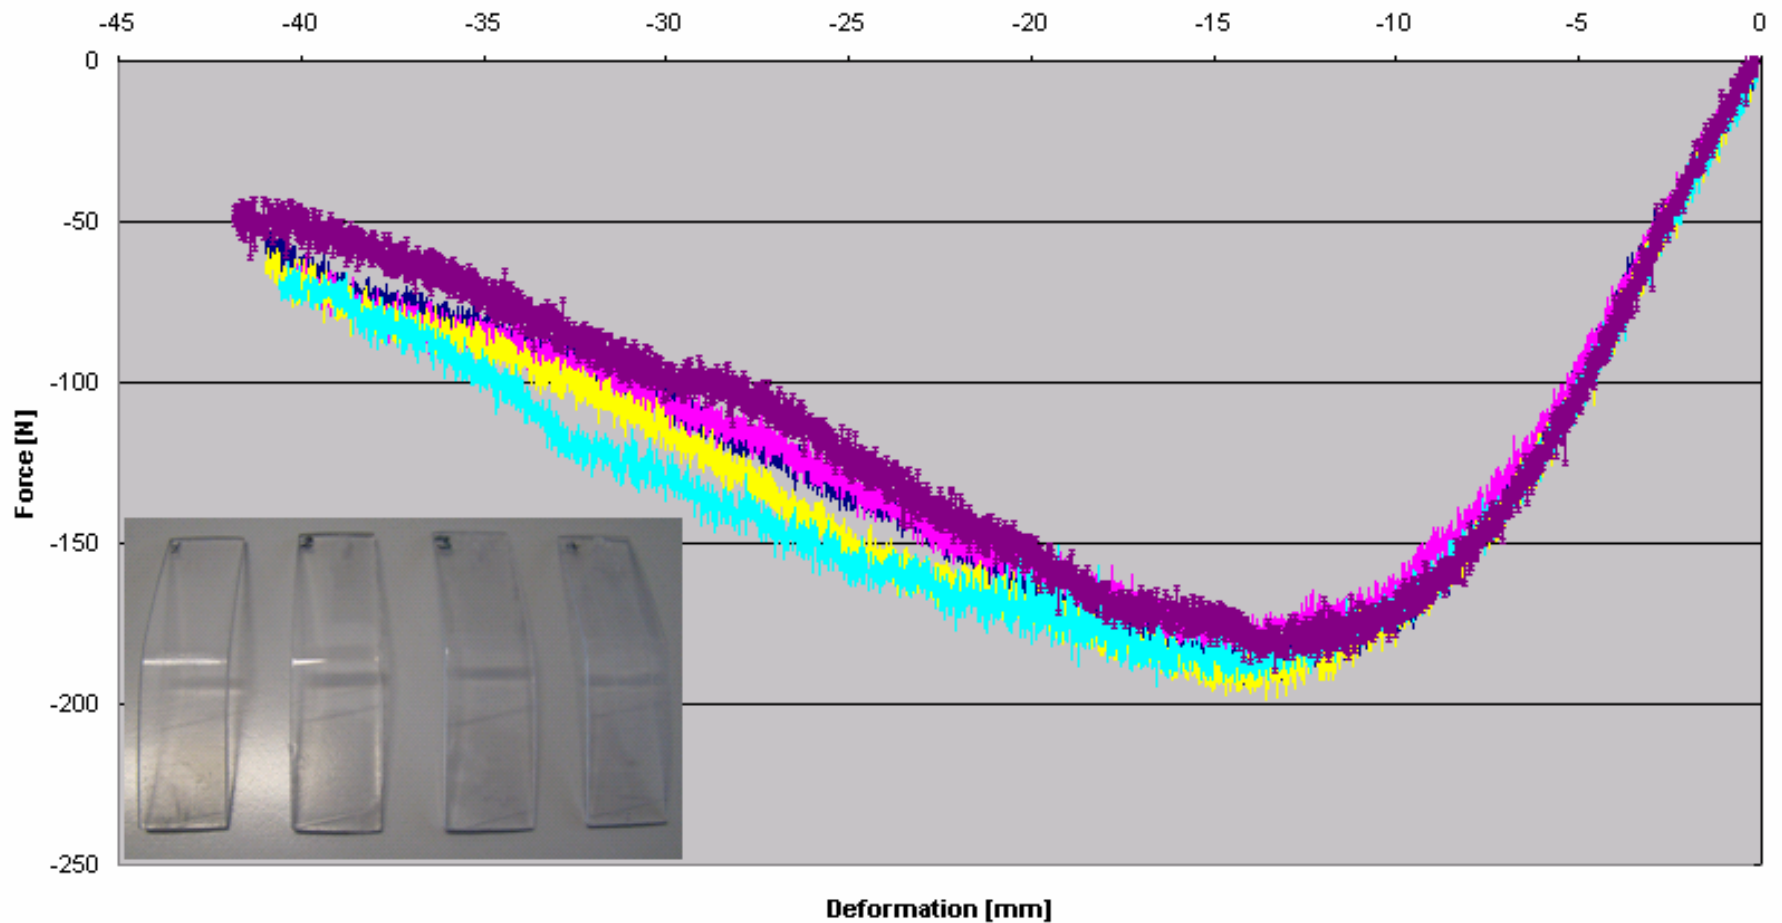
Two-component Paint

Results of the mechanical tests

— Painted - exposition in climatic chamber — Painted — Painted - detergents and hydrocarbons attacks — Painted - exposition at sun light — Master

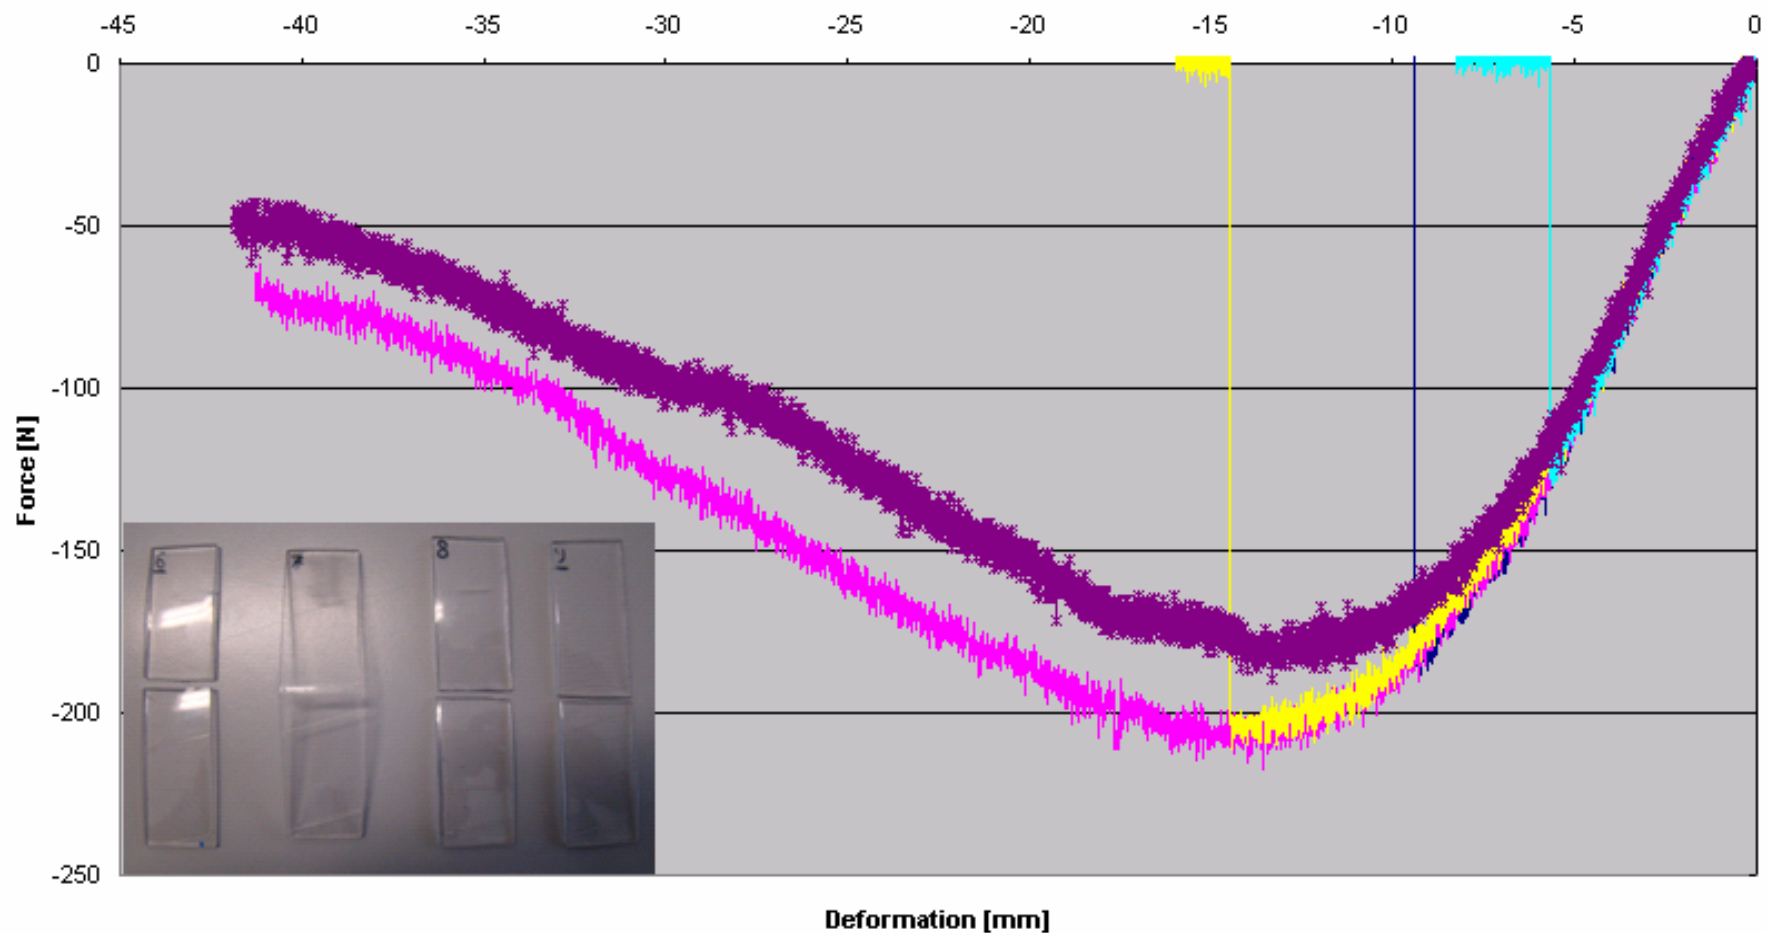
One-component Paint

Results of the mechanical tests

— Painted - exposition in climatic chamber — Painted — Painted - detergents and hydrocarbons attacks — Painted - exposition at sun light — * — Master

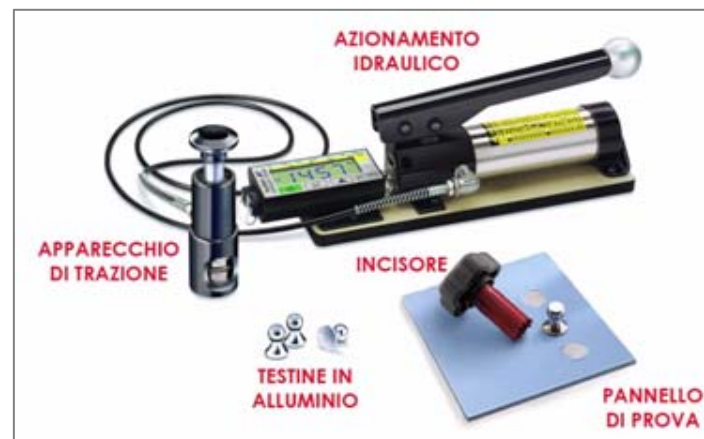
Pull off test

- The test has been carried out in compliance with the norms : UNI EN ISO 16276-1; UNI EN ISO 4624, to assess the adhesion level of paint to the support;
- This test consists in sticking an aluminum dolly on a painted support, to carry out a traction test

Specimen (Paint Type)	Treatment	σ [MPa]	F [N]
1 (two-comp.)	Exposition in climatic chamber	0,46	144,5
2 (two-comp.)	Nothing	0,93	292,16
3 (two-comp.)	Detergents and hydrocarbons attacks	0,91	285,88
4 (two-comp.)	Exposition at sun light and chemical agents attacks	0,49	153,93
6 (one-comp. UV)	Exposition in climatic chamber	0,93	292,16
7 (one-comp. UV)	Nothing	0,96	301,59
8 (one-comp. UV)	Detergents and hydrocarbons attacks	0,89	279,6
9 (one-comp. UV)	Exposition at sun light and chemical agents attacks	0,81	254,46
11 (master)	Nothing	3,77	1184,4
